**Courthouse Square Historic Preservation Commission
October 3, 2016**

CSOHPC Case #228

Applicant: Homeward Bound, Inc.
Address: 426 South Lamar Blvd

Homeward Bound, Inc. proposes replacing an existing window because of termite damage and broken glass. The current window and awning faces and is visible from the building's S. Lamar Boulevard frontage. The window was originally part of the garage door of the building, but has since been covered with the existing awning and sheet rock. During demolition work within the interior of the building, termite damage and rotting was discovered. The applicant plans to replace the awning with three replacement windows located above one replacement window adjacent to the exterior door, and one exterior door to coordinate with the proposed windows. The applicant is also proposing to replace a broken exterior light fixture with a new fixture similar to one in the attached photos.

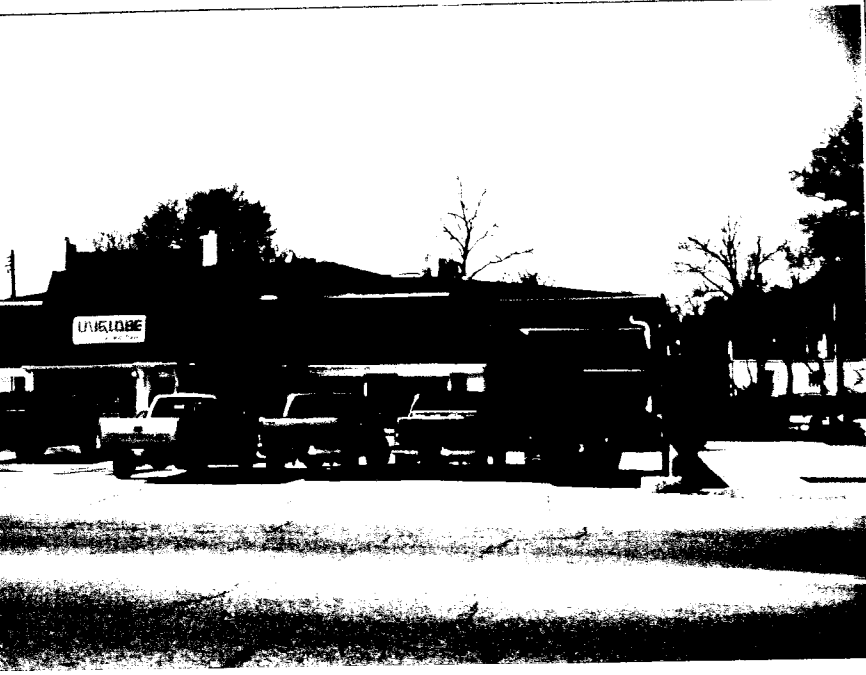
12. Brief Description: One-story, four-bay, brick masonry Pure Oil gas station built in ca. 1930, with one-story, seven-bay, brick masonry associated rear automobile service facilities, altered in ca. 1970. Gas station has side gable roof covered with asphalt shingles, with flush eaves, multi-light and single-light fixed display windows and a nine-light replacement door. Rear service facilities have flat, and added shed and Mansard roofs. multi-light fixed display windows, and multi-light doors.
